Failure Analysis in Forgings after Heat Treatment -Case Studies

Abstract— In this case study, metallurgical analysis of defects encountered during forging of input shaft and stub axle has been done in detail. Hence, in order to find the root cause of failure & to study the different defects during forging process. Study was carried out, aim of the case study was to find out reasons behind the cracks, to study the process of forging and the defects encountered during the forging process. A complete failure analysis was done on rejected input shaft & stub axle which had developed defects during forging. Different parameters were taken into consideration and various tests were performed to find the reason behind the failure. In the end some corrective actions and suggestions will be provided in order to improve the process and to counter the reasons that cause cracking of input shaft and stub axle during forging.

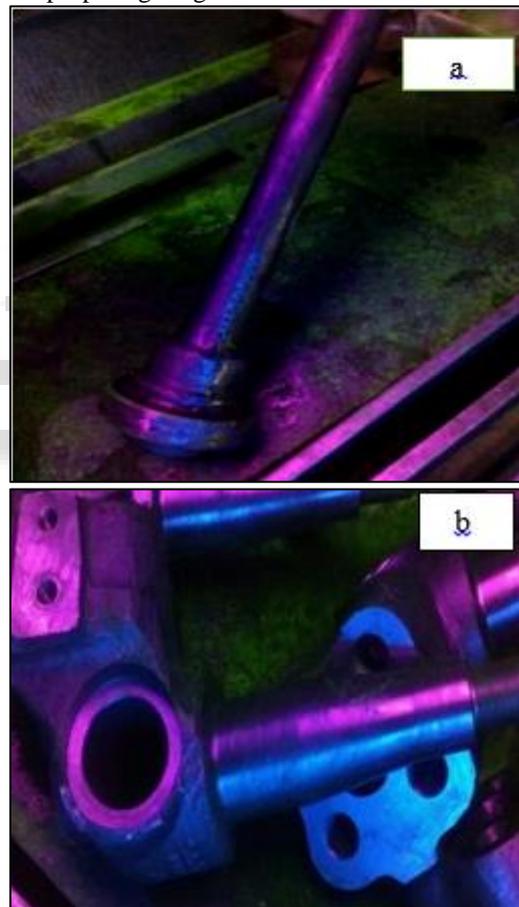
Fig. 1: Showing Surface Crack in the Surface of Input Shaft and Stub Axle (a and b)

Fig.1 (a) show the surface the surface crack in the surface of input shaft and the fig 1 (b) show the surface crack in the surface of stub axle that crack is found with the help of magnetic particle inspection (MPI). The Magnetic Particle Inspection (MPI) method (Nondestructive type) is applicable for detecting surface and subsurface defects, which are not visible to naked eye. The magnetic particle method is based on the PRINCIPLE that — Magnetic field lines when present in a ferromagnetic material will be distorted by a change in material continuity, such as a sharp dimensional change or a

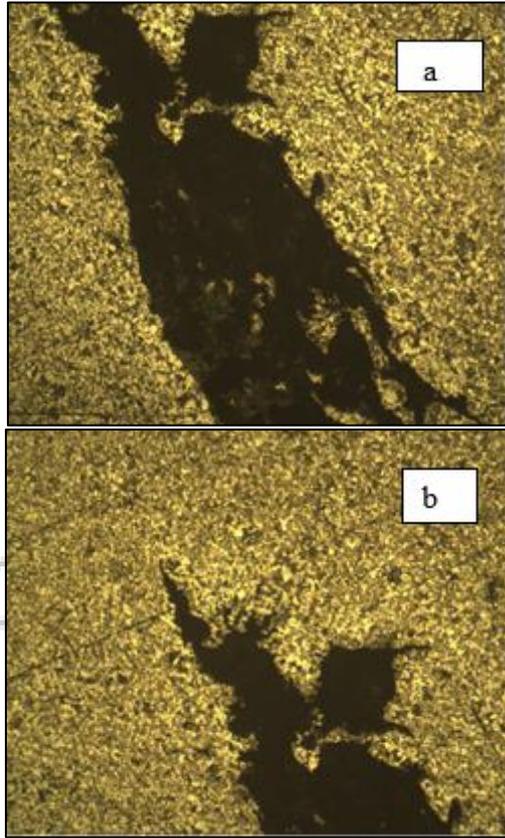
Fig. 2: Microstructure of surface crack in the input shaft (a and b) at 100X

Fig 2 (a & b) show the microstructure of input shaft at 100X. microstructure show the nature of crack present in the surface of input shaft. With the help of SEM/EDX testing we analysis the crack and tell the reason of crack in input shaft.

Fig 3 (a & b) show the microstructure of stub axle at 100X. microstructure show the nature of crack present in the surface of stub axle. With the help of SEM/EDX testing we analysis the crack and tell the reason of crack in stub axle. Fig 2 and Fig 3 show the microstructure of input shaft and stub axle at 100X. input shaft has been forged and normalize hence in the microstructure of input shaft pearlite structure has shown. Surface crack is shown clearly in the microstructure of input shaft (Fig2).

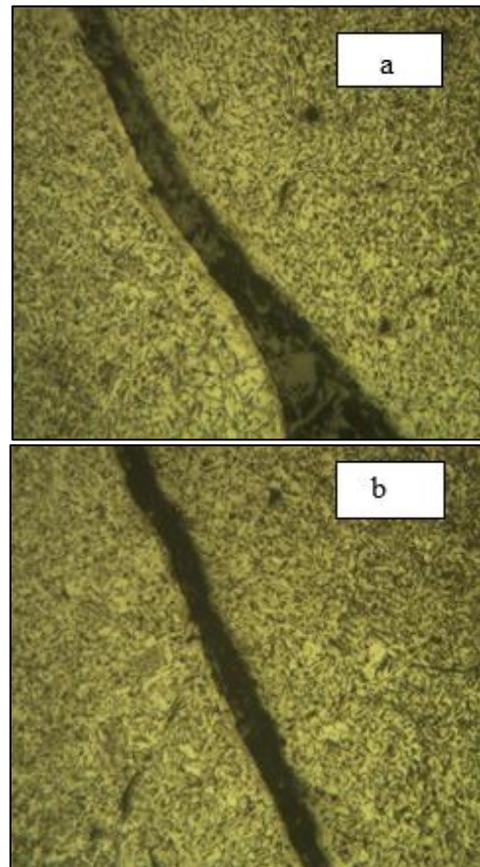
Fig. 3: Microstructure of Surface Crack in Stub Axle (a & b) at 100X.

Stub axle has been forged and hardened and tempered microstructure of stub axle shown the crack in the surface of stub axle. (Fig3). Residual stresses is present in the material these stresses could have been introduced in stub axle during heat treatment operation.

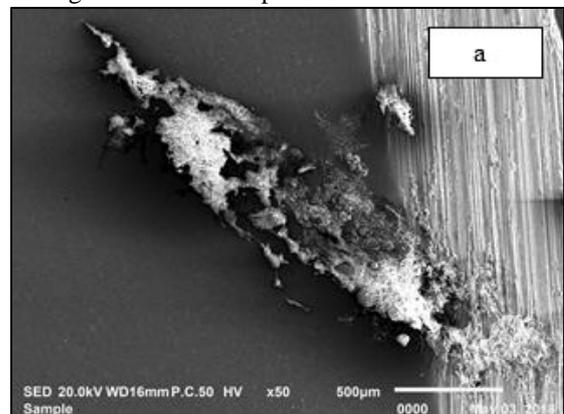
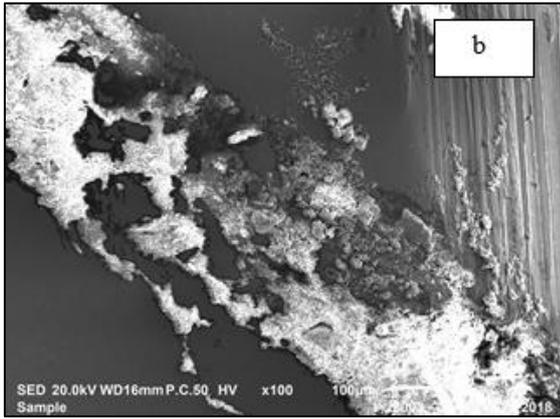
Fig. 4: SEM Images of Input Shaft (a & b)

SEM images of input shaft show the scaling present in the surface of input shaft. Scaling is entrapped during rolling process. This is seen as irregular deputation on the surface. This is primarily caused because of improper cleaning of the stock used in forging. The oxide and scale get embedded into the finish forging surface. When the forging is cleaned by pickling, these are seen as deputation on the forging surface.

Fig 4 and Fig 5 show the SEM images of input shaft and stub axle respectively. SEM image of input shaft show the scaling entrapped in the surface of input shaft. SEM image SEM images of input shaft show the scaling present in the surface of input shaft. Scaling is entrapped during rolling

process. This is seen as irregular deputation on the surface. This is primarily caused because of improper cleaning of the stock used in forging. The oxide and scale get embedded into the finish forging surface. When the forging is cleaned by pickling, these are seen as deputation on the forging surface.

- SEM/EDX analysis of input shaft revealed scaling is entrapped during rolling process.
Remedy-proper cleaning of stock prior to forging.
- SEM/EDX analysis of stub axle revealed the initiation of crack in the stub axle appears to be due to high residual stresses and presence of segregation particle in the material. These stresses could have been introduced in the stub axle during the heat treatment operation.
Remedy-slow cooling of the forging in a furnace or under ash cover a period of time.

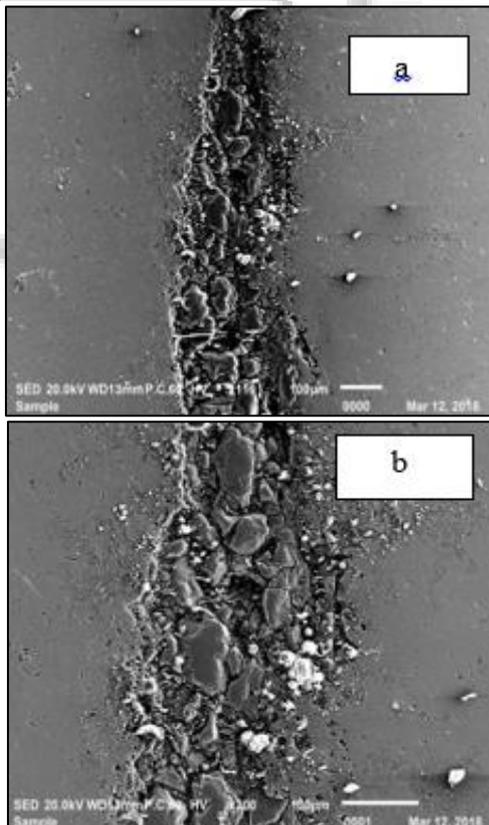
Fig. 5: SEM Images of Stub Axle (a & b)

SEM image of stub axle revealed the initiation of crack in the stub axle appear to be due to high residual stresses and presence of segregation particle in the material. These stresses could have been introduced in the stub axle during the heat treatment operation.

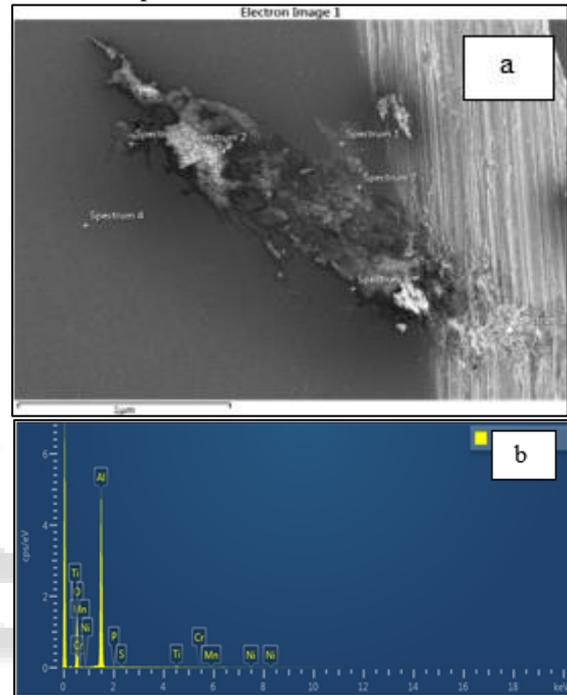
Fig. 6: EDX Analysis of Input Shaft (a & b)

EDX Analysis of input shaft revealed scaling is present in the material.

SEM/EDX images of input shaft show the scaling present in the surface of input shaft. Scaling is entrapped during rolling process. This is seen as irregular deputation on the surface. This is primarily caused because of improper cleaning of the stock used in forging. The oxide and scale get embedded into the finish forging surface. When the forging is cleaned by pickling, these are seen as deputation on the forging surface.

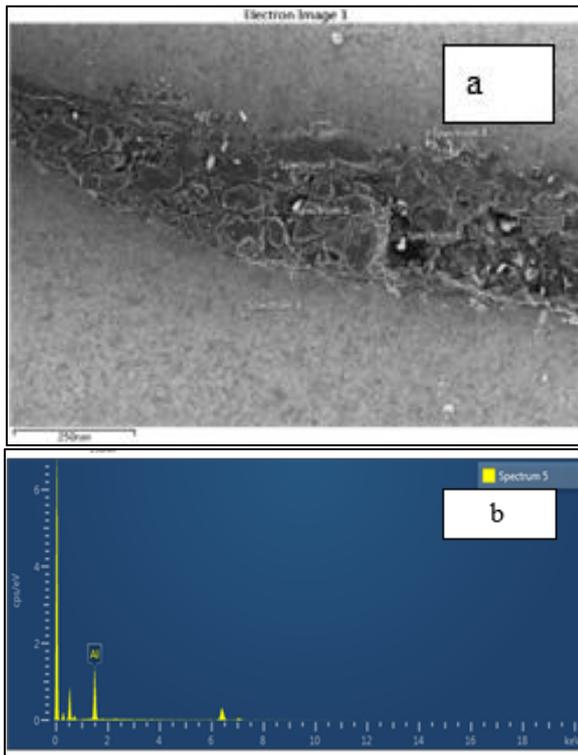
Fig. 7: EDX Analysis of Stub Axle Shaft (a & b)

EDX analysis of stub axle revealed that the segregation is present in the material

SEM/EDX image of stub axle revealed the initiation of crack in the stub axle appear to be due to high residual stresses and presence of segregation particle in the material. These stresses could have been introduced in the stub axle during the heat treatment operation.
