# The Effect of Poor Drainage on Road Performance in Hargeisa

Mukhtar Yousuf Ali

University of Hargeisa

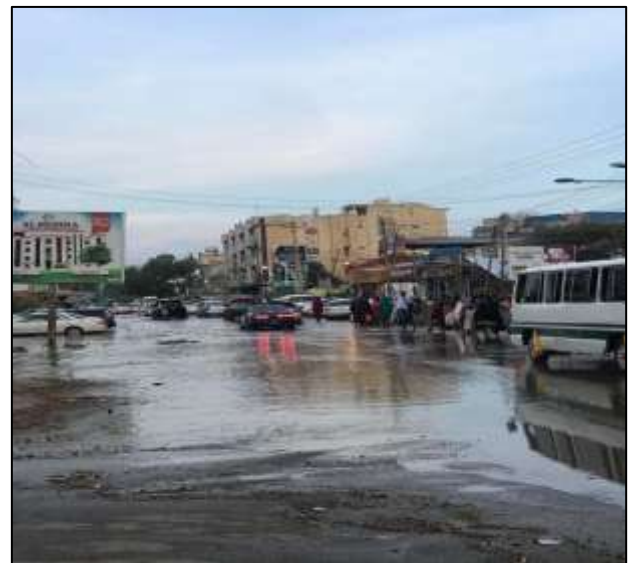
Recently Hargeisa is facing extensive water logging during the rainy season (April to August) as a result of the serious problem of poor drainage. Inadequate drainage problems become one of the most common sources of complaint from the residents in Hargeisa city and this problem becoming worse year after year. Poor existing drains and their improper operation and management mainly cause serve flooding which creates damage and problems to the road pavement and road users. As shown in Figure 1 a flood obstructed traffic flow.

Fig. 1: Flooded road obstructed traffic flow

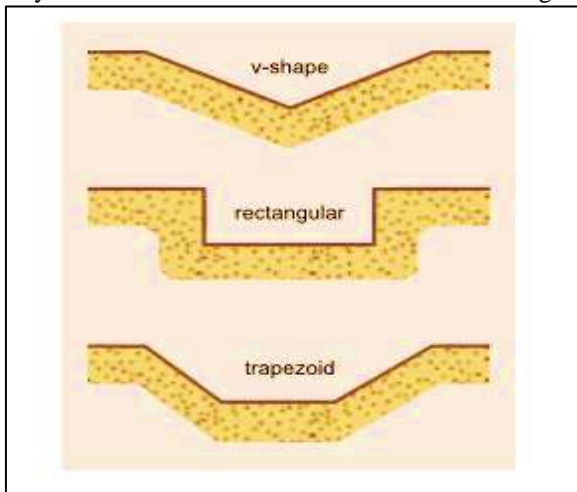
Fig. 2: The common shapes of side drains.

Side's drains can be constructed in three common forms Rectangular shape, V- shape, or a trapezoid as shown above (figure 2). The V-shape is the standard shape for drains or ditches constructed by the motor grader. However, it carries a lower capacity than other cross-section shapes the rectangular shape requires less space but needs to be lined with rock or concrete to maintain its shape. This shape is often used in urban areas where there is limited space. The trapezoid-shaped side drain carries a high flow capacity and by carefully selecting the right gradients for its side slopes, will resist erosion. In urban areas especially commercial and residential areas the drains should be covered with concrete slabs or small blocks for easy inspection and cleaning. The exact dimensions of the side drains are dependent on the expected amount of rainwater and the distance to the next existing point where the water can be diverted away from the road. The rational method and manning formula can be used in calculations. In flat or slightly undulating terrain, a longitudinal slope is to be used between 2% and 5% in drains. With gradients, less than 2% silting occurs easily while with gradients steeper than 5% the ditches will easily erode. Use rubble. Or fabric to slow water flow on the steep slope, or pave them to prevent serious erosion. Installing a short section of storm sewer may also be considered.

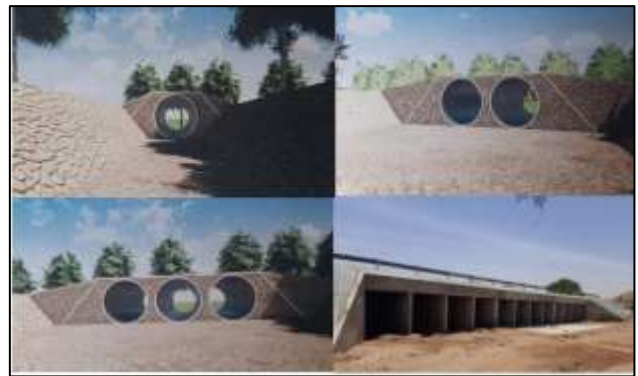
Fig. 3: Types of culvert outlets, end wall structures, and wing walls.

Culverts are constructed using different materials. The most common practice of culverts is based on the use of precast concrete pipes, in-situ concrete boxes, and corrugated steel pipe culverts. The box culvert is generally built with 1,2,3,4, cell of width 1m to 3m, and the pipe culvert is built with 1 to 3 rows of pipes with diameters commonly ranging from 0.6m to 1m. Wing walls and aprons of concrete or stone pitching are used to protect the culverts from water flow erosion and scouring on the upstream and downstream sides. Culverts should slope enough so water will flow. A minimum drop of 15cm across the road is desirable. This will keep sediment from accumulating in the culvert but will not cause extensive erosion at the discharge end.

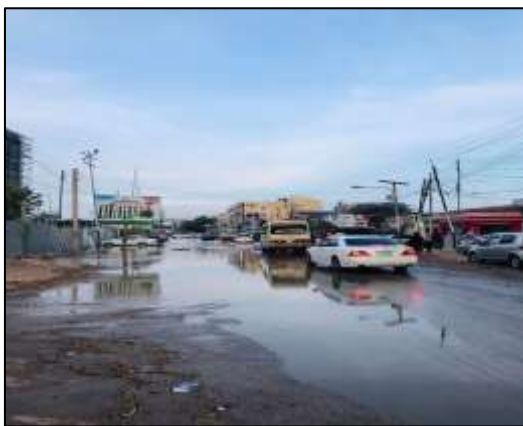
Fig. 4: The side drains and the culverts were blocked with sand accumulation garbage and roots.

Study. It was observed that the part of the carriageway of the road is connected with a side drain located far from the edge of the road at a distance of about 4m in general, most of the drain is open earth drain with a small cross-section of 1m width and not more than 1m depth. The condition of the drain and its structures is very poor and getting deteriorated with time. The drain suffered from low capacity, natural siltation, absence of inlets, indefinite drainage outlets, lack of proper maintenance, and over and above disposal of solid waste into the drain and the crossing culverts. The drain is blocked with sand accumulation, rubbish, and roots as shown in photo 2. It is clear that the drain and culverts are being converted into dumpy places and subsequently obstructing the water flow.

Even if the drains and their structures, and culverts are well built they need adequate maintenance for sustainability. One of the main problems of drainage development in Hargeisa is attempted it is done unsystematically. The financing of the maintenance, rehabilitation, and conservation of the drainage network system in Hargeisa had always been left to the government at the state and local levels who because of their lack of maintenance culture do not release funds for drainage maintenance at the appropriate time. The drainage network was therefore left to deteriorate. The drainage worldwide was considered critical infrastructure in any nation's life and was paid premium attention.

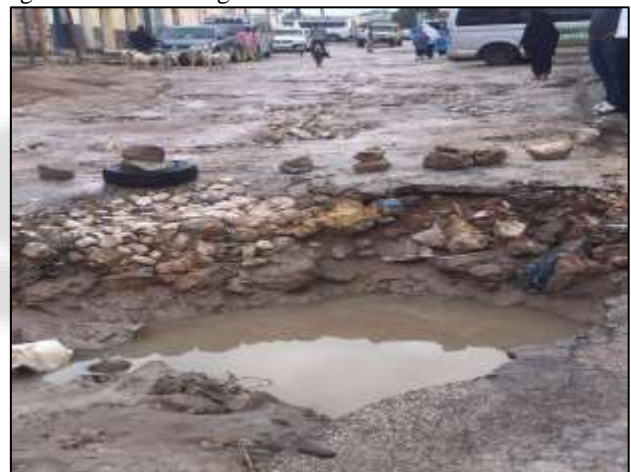
This bad condition of the side drain and its structures remains the same throughout the year causing the runoff water to flow on the surface of the road and unable to run off through the path far from the failed drain. The resultant effect of this critical situation causes serious distress and damage to the pavement. The road edges suffered from the detachment of the asphalt layer due to continuous contact of water leading to the stripping of asphalt from aggregates resulting in severe pavement distresses of cracking, potholes, and failure of edges as shown in Figure 5.

Fig. 5: Severe pavement distresses cracking, potholes, and failure edges.

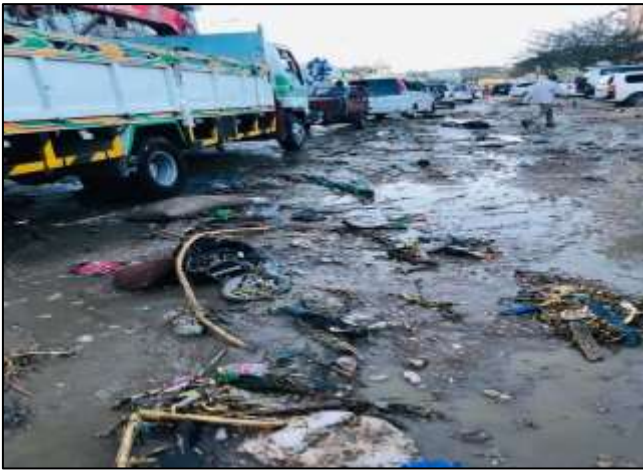
The road suffered from severe distresses of potholes, cracking, rutting, and heavy depressions. Rehabilitation of the road was carried out in 2019 by Hargeisa local municipality.

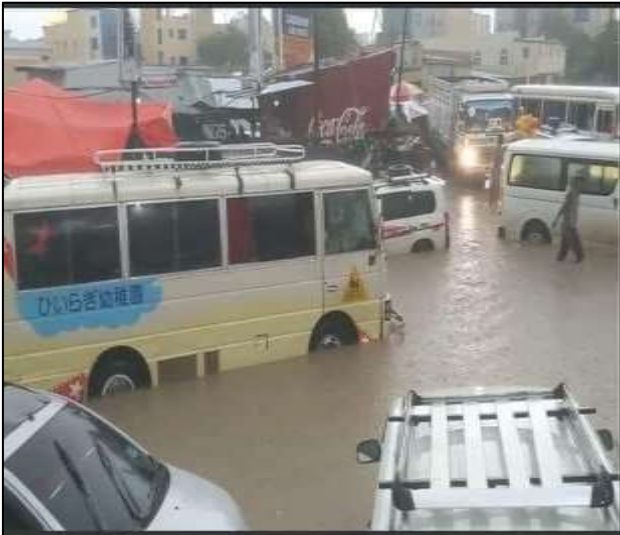
During excavation work, it was observed that the subgrade soil was fully saturated with surface water encountered at 1m depth. As seen in figure 4. Accumulation of sewage water disposed of neighbor houses into the subsoil.

Fig. 6: Accumulation of subsurface water on the road.

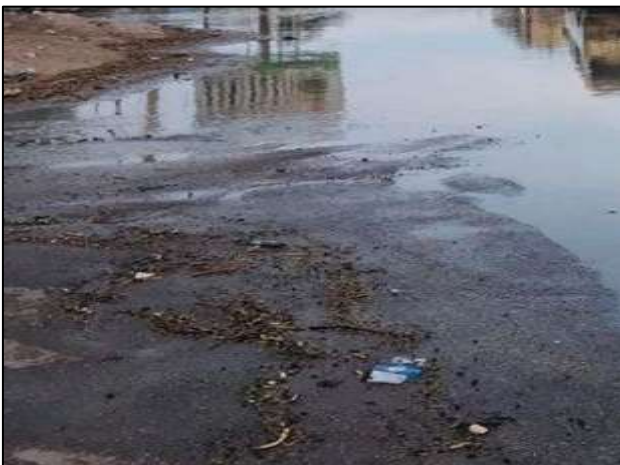
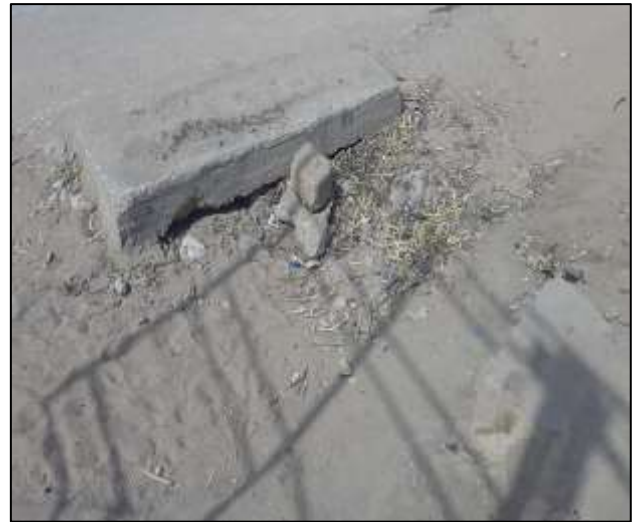
In the field survey, it was observed that the side drain was full of dirty water and refuse dumps. The inlets on the curb were blocked with soil accumulation as shown in

Fig. 7: The side drain is full of refuse dumps and dirty water.

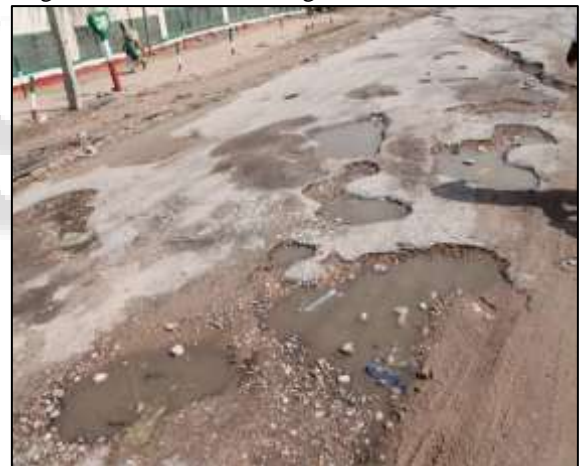
Failure and serve distress were observed on the road surface. It was found that the surface runoff water penetration through the cracks and potholes causes a progressive inward penetration of the zone of soil movement leading to soil expansion and ultimately failure of the pavement. Therefore, the major cause of pavement deterioration is inadequate drainage. Significant cracking, potholes, heavy depression, and edge failure as shown in Figures 8 & 9.

Fig. 8: Serve failure of road edge due to water ponding on surfaces.

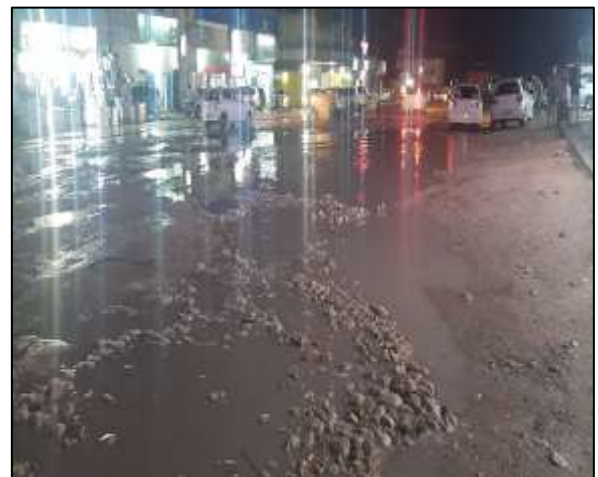
Fig. 9: Serve failure of edges and potholes.
