Design, Analysis & Optimization of Pivot of Rocker Arm

Abstract— Rocker arms are part of the valve-actuating mechanism. Over the years rocker arms have been optimized in its design and material for better performance. Durability, toughness, high dimension stability, wear resistance, strength and cost of materials as well as economic factors are the reasons for optimization of rocker arm. Various types of rocker arm used in vehicles and different materials used for making rocker arm are studied in this paper. Failure of rocker arm is a measure concern as it is one of the important components of push rod IC engines. Present work finds the various stresses under extreme load condition. For this we are modeling the arm using design software and the stressed regions are found out using Ansys software. Rocker arm is the important component of engine assembly in this paper we consider rocker arm and through the literature finite element analysis(FEA)in ANSYS is done for five different material viz. Aluminum alloy, chromium molybdenum, grey cast iron, HSS, structural steel. The result of ANSYS shows that structural steel is the best material for rocker arm. The result of software is valid

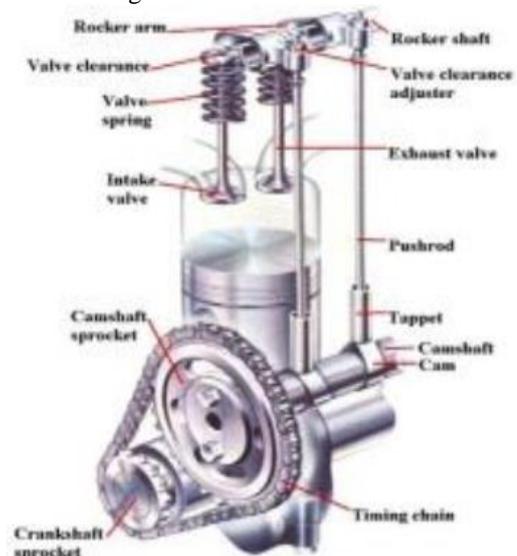
Fig. 2: Valve Train Assembly

Rocker arm is an important part of the valve train in fuel injection system providing not only the means of actuating the valves through a fulcrum utilizing the lifter and the push rod but also provide a means of multiplying the lift ratio. Cam shaft design has advanced in leaps and bounds over

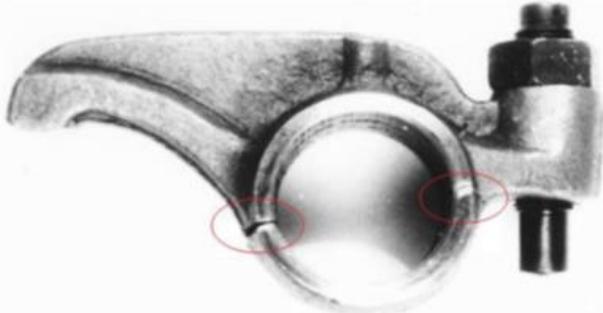
The fracture occurred at the hole of the rocker arm. Multiple origin fatigue is the dominant failure mechanism. The spheroidisation of cementite in pearlite makes the hardness of the material of the failed rocker arms decrease to result in lower fatigue strength. Initiation and growth of the cracks was facilitated by a microstructure of low fatigue strength. The fracture of rocker arm at the hole is shown in fig.

Fig. 3: Fracture of Rocker Arm at the Hole

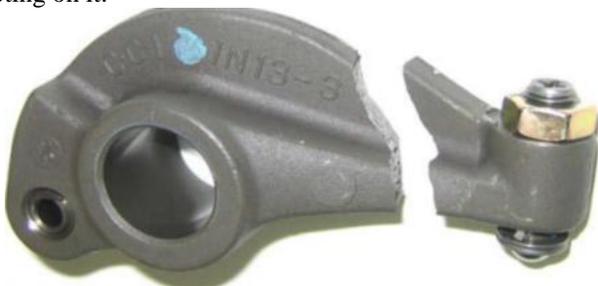
The ultimate tensile strength (UTS) and elongation of the rocker arm material were 164.0 MPa and 2.5%, respectively. This UTS value is slightly lower than that of normal die-cast Al alloys. In the stress measurement test, the compressive stress exhibits the maximum value at the idling state and decreases as the engine speed increases. The maximum experimental stress at the neck was 21.0 MPa at the engine idle speed. Hence, this rocker arm is deemed to be safe in terms of fatigue fracture, taking into consideration the fatigue endurance limit of 58.8 MPa. The safety factors of this component are 2.6 and 3.8 based on the fatigue endurance limit and the modified fatigue endurance limit, respectively, suggesting that this S.F is appropriate. However, gas porosities introduced during the die-casting process provide sites of weakness at which premature fatigue crack initiation and finally fatigue fracture of this rocker arm can occur. Therefore, it is necessary to control the melt quality during the diecasting process in order to secure the safety of this type of rocker arm due to stresses acting on it.

Fig. 4: Failure of a rocker arm at neck

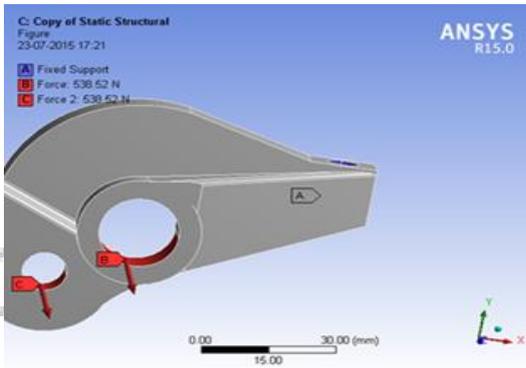
Fig. 6: Finite element analysis by ANSYS of 5 different material static structural diagram of rocker arm

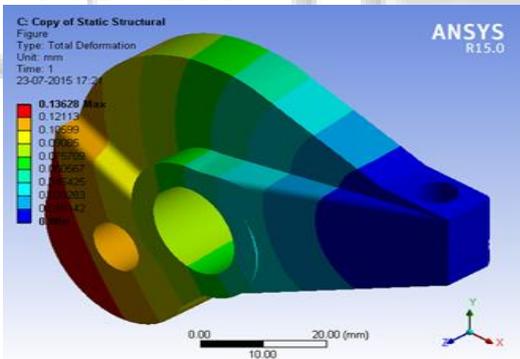
Fig. 7: Total Deformation

1) Aluminum Alloy

a) Total Deformation

Type of material	Maximum Von-Mises stress(mpa)	Minimum Von-Mises stress(mpa)	Total Deformation (mm)
Aluminum Alloy	169.16	2.431×10^{-2}	0.1362
chromium molybdenum steel	181.86	1.9171×10^{-2}	0.04605
Grey cast-iron	179.76	1.8786×10^{-2}	0.0879
High strength steel	175.42	1.9703×10^{-2}	0.0460
Structural steel	160.74	2.1727×10^{-2}	0.0440

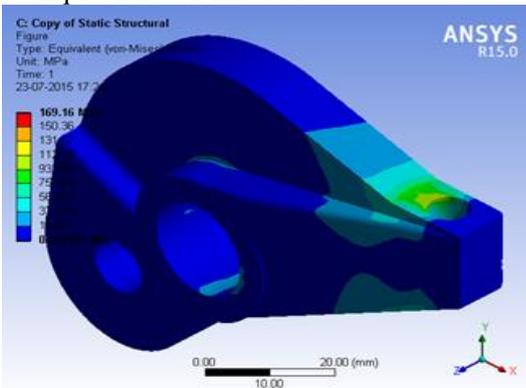
Fig. 8: Equivalent von-mises stress

b) Equivalent von-mises stress

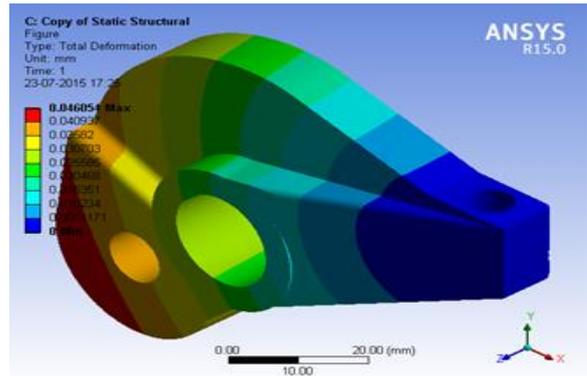
Fig. 9: Total Deformation

2) Chromium Molybdenum Steel

a) Total Deformation

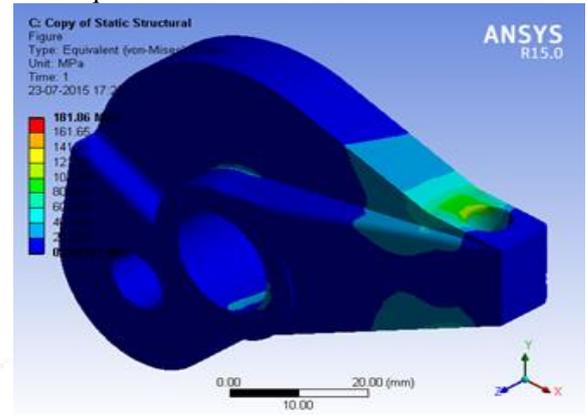
Fig. 10: Equivalent von-mises stress

b) Equivalent von-mises stress

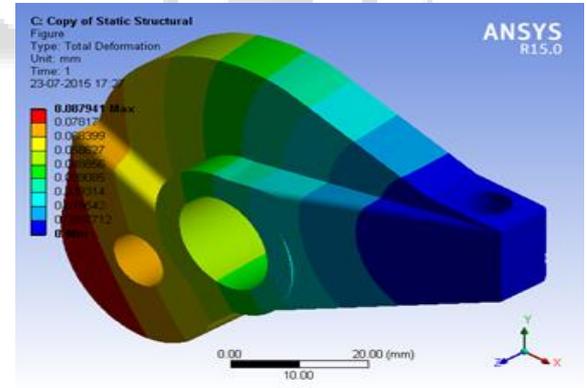
Fig. 11: Total Deformation

3) Gray Cast Iron

a) Total deformation

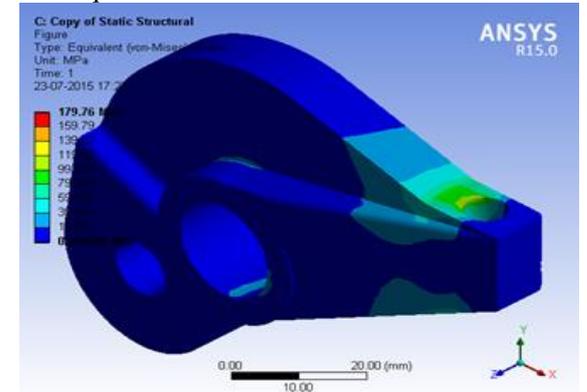
Fig. 12: Equivalent von-mises stress

b) Equivalent von-mises stress

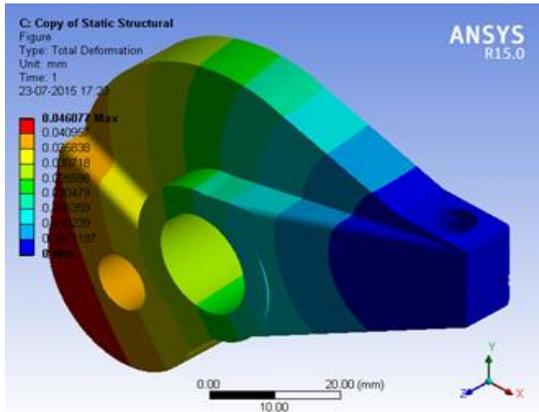
Fig. 13: Total Deformation

4) High Strength Steel

a) Total deformation

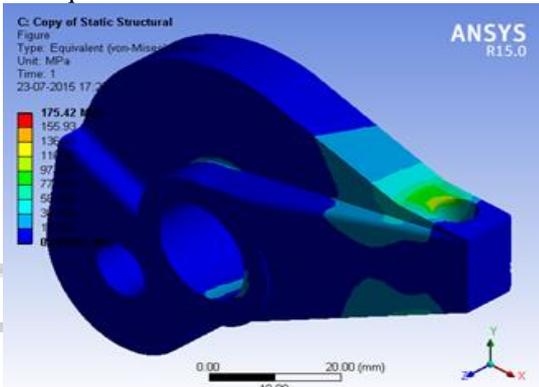
Fig. 14: Equivalent von-mises stress

b) Equivalent von-mises stress

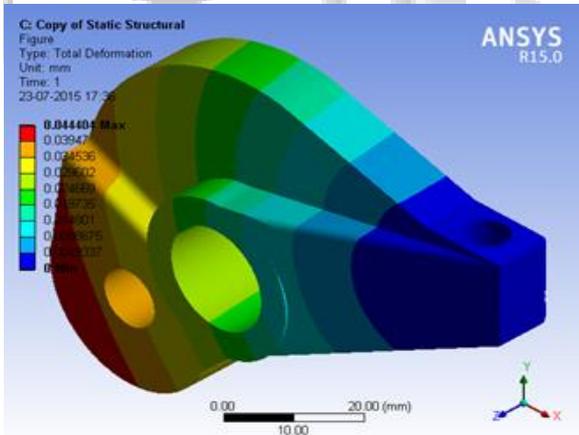
Fig. 15: Total Deformation

5) Structural Steel

a) Total deformation

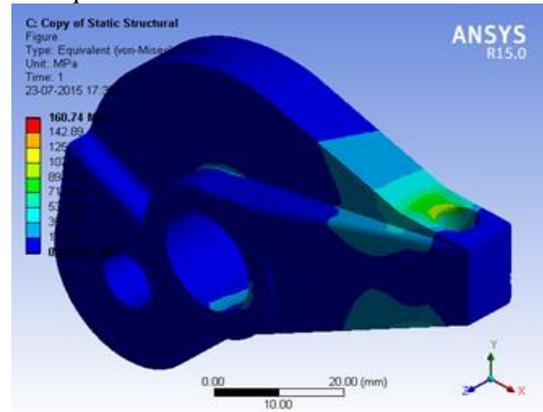
Fig. 16: Equivalent von-mises stress

b) Equivalent von-mises stress

The modeling of the rocker arm is done by using pro-e and the analysis is performed by ANSYS. The project consists of structural analysis of rocker arm which is done to find the strength of the model. To find the strength of the model in structural analysis we are taken 5 different materials like Aluminum Alloy, chromium molybdenum steel, Grey cast-iron, High strength steel Structural steel and taken 2 load points on model. We did analysis on the model by applying loads on point of two holes on rocker arm by varying different 5 materials. By the results we observed that the stress and deformation is the main criteria. The literature shows structural steel has better fatigue strength and stiffness. The of FEA and experimental testing on UTM result shows less deformation and less stress of structural steel. Hence structural steel is the better material for rocker arm among all available material.
