A Study on Existing Sidewalks to Interpret the Condition of Pedestrian Facilities using the Concept of Level of Service (LOS) in Urban Suburbs of Sri Lanka

U. A. C. Perera¹ R. A. C. J. Seneviratne² A. S. S. Niyomal³

^{1,2,3}Sri Lanka Institute of Information Technology (SLIIT), New Kandy Road, Malabe, Sri Lanka

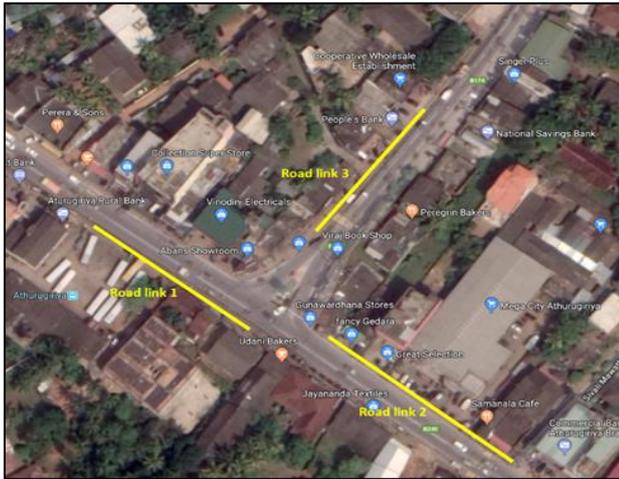
Fig. 1: Identified Road Links at Athurugiriya Junction

For this study two main city centers, "Kaduwela" and "Athurugiriya" in Colombo districts were selected based on the facts that these two city centers are identified as suburbs of Colombo and very high pedestrian flows are visible throughout the day. Also, proper pedestrian facilities are not available in sidewalks of these city centers. Identified road links for the study in these two city centers are shown in Fig. 1 and Fig. 2.

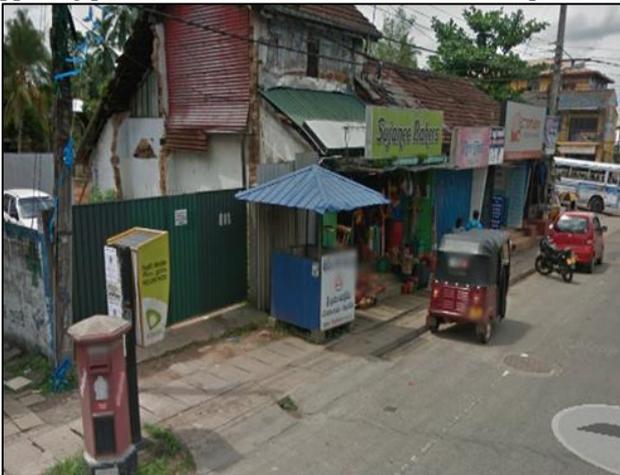
Fig. 1: Unprotected Sidewalks at Athurugiriya Junction

Also during the study, it was identified that none of the considered sidewalks are protected with safety fence as shown in Fig. 3 and Fig. 4. Where, safety fence is a major component in pedestrian facilities providing safety for the pedestrians from roadside accidents and limiting unauthorized roadside parking along sidewalks. Hence provision of fences would reduce the possibility of pedestrians entering carriage way in the road. Therefore, provision of safety fences for road links 2,5 and 6 probably would help to enhance the Level of service with these links are expected to have very high pedestrian capacity during peak hours.
