Study on the Behaviour of Reinforcing Bars and Concrete Exposed to Fire-Review

Abstract— In this modern era, most of the buildings all the world are made up of RCC. The increasing incidents of fire in buildings have increased the importance of assessment; repairs and rehabilitation of such buildings as these buildings are very costly. This field needs special expertise in many areas viz. concrete technology, structural engineering, material testing, and repairs and maintenance etc. A continuous effort through research and development programmes all over the world is being made in this specialized field. This topic gives us immense pleasure as we deal with the real life problems in this research. In this research, we gain the knowledge which is being used as a strategy for the rehabilitation of fire damaged buildings and by conducting proper assessment procedures by non-destructive techniques. It is known that most of the fire damaged RCC are restorable. The mechanical properties of all common building materials decrease with the elevation of temperature. The behavior of a RCC in fire conditions is governed by properties of constituent materials, concrete and steel at high temperat

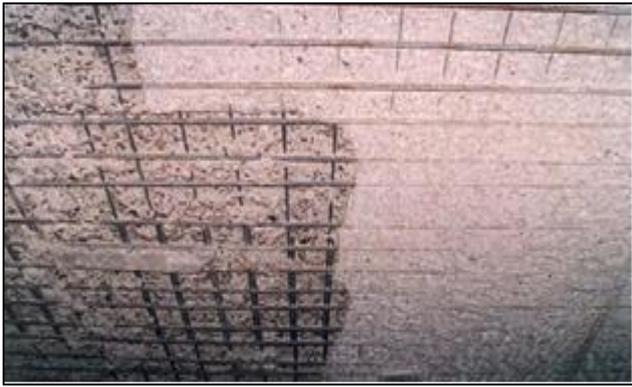
Fig. 1: Fire Damaged Slab

The properties of concrete changes suddenly when exposed to high temperature, many problems were experienced with concrete in fire like change in mechanical properties. Rise in temperature due to fire up to 90°C have little effect on the strength and other properties of concrete in a structure. Failure of concrete in a structure due to fire depends upon the type of structure, loading system and nature of fire. Reason of failure could be from loss of bending strength; loss of compressive strength and spalling of concrete.

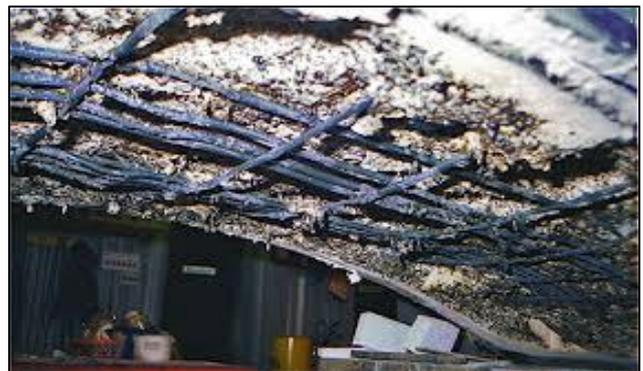
Fig. 3: Spalling of Concrete due to Fire

Spalling is the breakaway of concrete surface from the concrete member due to the result of water entering the concrete. Spalling happens due to the presence of moisture present in concrete. It generally happens to old buildings. Due to spalling, reinforcing bars gets exposed to atmospheric moisture which in turn reduces the strength, durability and stiffness of the structural member. So, as soon as spalling is spotted, it should be properly repaired otherwise it compromises with concrete surface integrity.

- When the spalling damage is shallower than 1/3 of the concrete's thickness, the concrete usually can receive a surface repair. If the damage is greater than 1/3 of the depth, steel bars may need to be installed and a full depth restoration may be required.
- Corroded rebar, due to exposure, must be cleaned at the beginning of the restoration process. Once the rebar is thoroughly cleaned (usually with a wire brush) and all corrosion is removed, the rebar should receive a protective coating of rust inhibitor to minimize future corrosion.
- Damage on driveways, walkways, and other horizontal surfaces may be repaired with a cementitious overlay. After the overlay has set completely, a waterproofing membrane should be applied to prevent spalling from recurring.
- Patching may be a repair option for random or localized damage. Patches should extend at least 4 inches beyond

- the spalled areas. For best results, the surface can be saw-cut in the patch area to help contain and secure the patch.
- Surfaces to be patched should be free of all debris and fine particles and should be completely dry before patching material is applied. It's best if the old concrete surface is rough to provide tooth for better bonding. The best patching materials are Portland-cement-based or epoxy and should be mixed immediately prior to application, as directed by the manufacturer.
- The air temperature must be over 40 F for patching or other restoration work to ensure proper bonding and curing of the repair material.
- Repair materials should have an expansion coefficient similar to that of the original concrete.
- Any joints that are repaired must allow for expansion of the concrete slab.

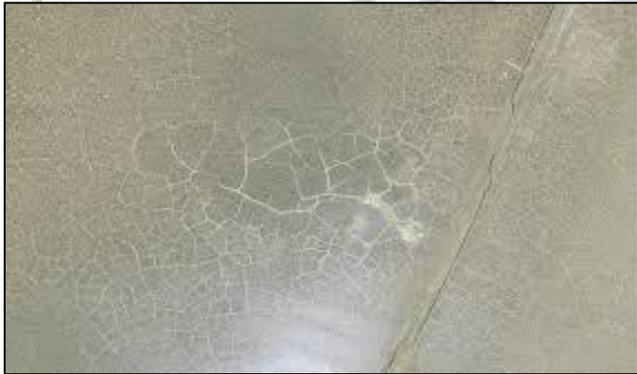
Fig. 4: Delamination of Concrete

Delamination of concrete may be defined as the detachment of thin layers of concrete from the concrete member. It can be detected by tapping the concrete surface by light hammer. If dull sound is heard indicates the presence of delamination. In the spreadsheet, it is indicated by the surface area to be recorded.

- Use of a sticky mortar mix with huge amount of fines.
- High rate of evaporation.
- Hastily performed finishing works.
