Study on Behaviour of Reinforcing Bars and Concrete of a RCC Structure Exposed to Fire

Abstract— In this modern era, most of the buildings all over the world are made up of RCC. The increasing incidents of fire in buildings have increased the importance of assessment; repairs and rehabilitation of such buildings as these buildings are very costly. This field needs special expertise in many areas viz. concrete technology, structural engineering, material testing, and repairs and maintenance etc. A continuous effort through research and development programmes all over the world is being made in this specialized field. This topic gives us immense pleasure as we deal with the real life problems in this research. In this research, we gain the knowledge which is being used as a strategy for the rehabilitation of fire damaged buildings and by conducting proper assessment procedures by non-destructive techniques. In this research, we did various experiments so as to find out the effect of fire on the reinforcing bars in RCC buildings by taking 6 samples at 110°, 310°, 610°, 900° each for 3 hours. After heating the samples, they are cooled quickly by quenching in water and normally by air

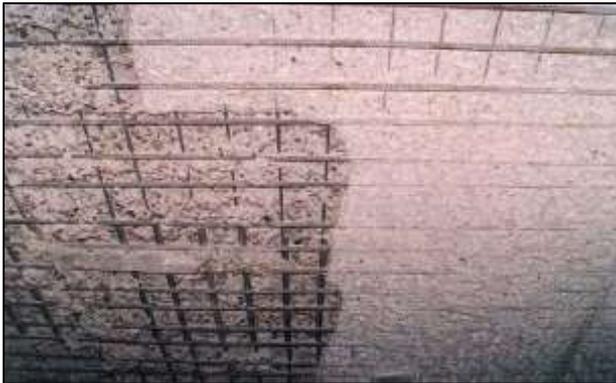
Fig1.1: Fire Damaged Slab

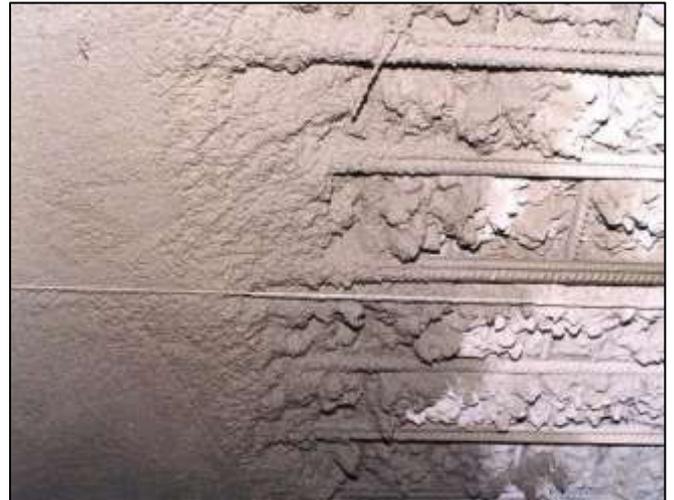
Fig 1.2: Concreting of Fire Damaged Slab

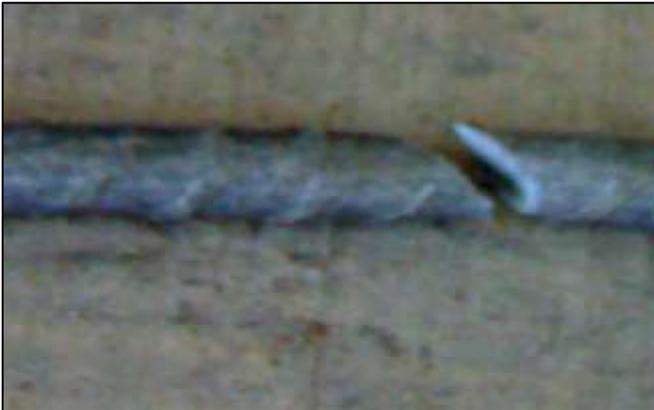
Fig. 4.11: Shear Failure of a Specimen

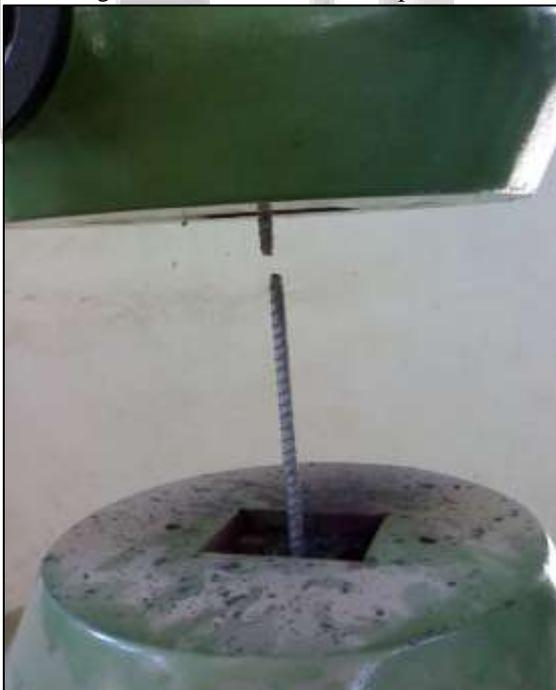
Fig. 4.12: Specimen failed on UTM.

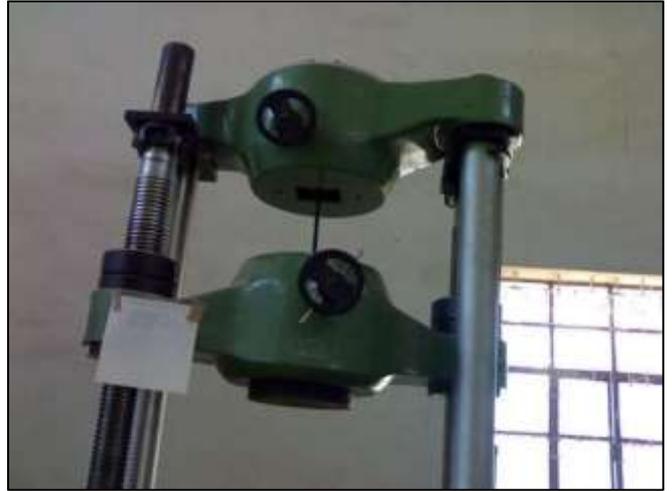
Fig. 4.13: UTM under working condition.
