Study on Exposure of Reinforcing Bars and Concrete Exposed to Fire – A Review

Sanjeev¹ Er. Sumit Sharma² Er. Sohail³

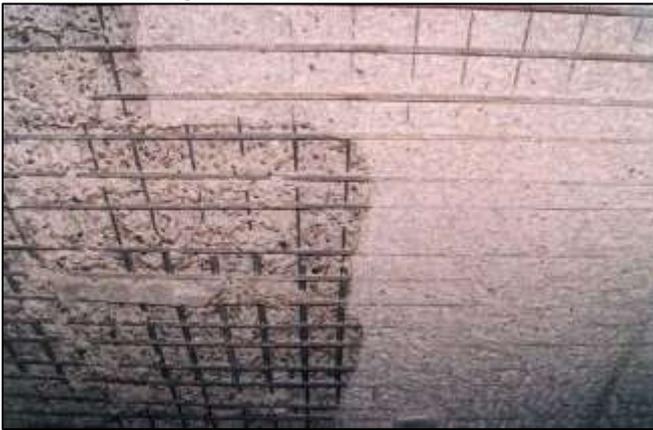
Fig. 1.1: Fire Damaged Slab

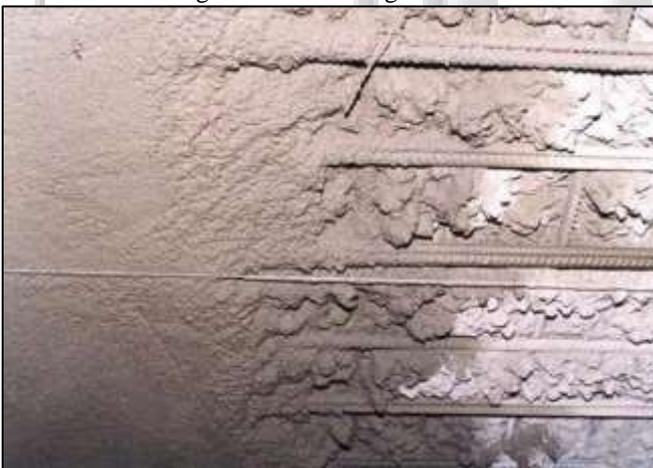
Fig. 1.2: Concreting of Fire Damaged Slab

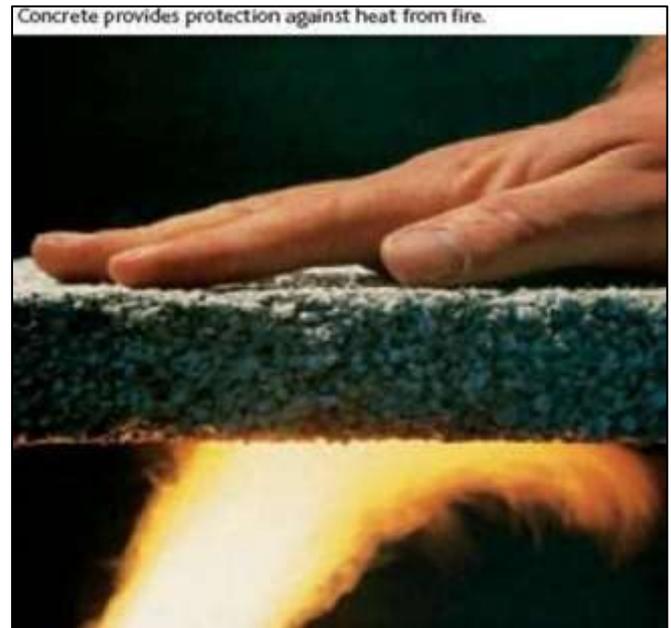
Fig. 1.3: Concrete against Fire

The properties of concrete changes suddenly when exposed to high temperature, many problems were experienced with concrete in fire like change in mechanical properties. Rise in temperature due to fire up to 90°C have little effect on the strength and other properties of concrete in a structure. Failure of concrete in a structure due to fire depends upon the type of structure, loading system and nature of fire. Reason of failure could be from loss of bending strength; loss of compressive strength and spalling of concrete.

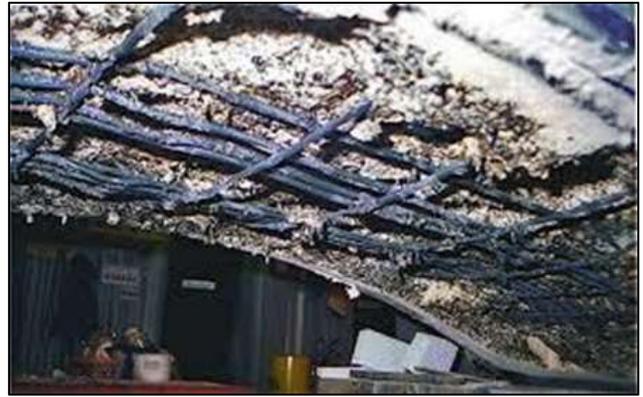
Fig. 1.4: Spalling of Concrete due to Fire

Spalling is the breakaway of concrete surface from the concrete member due to the result of water entering the concrete. Spalling happens due to the presence of moisture present in concrete. It generally happens to old buildings. Due to spalling, reinforcing bars gets exposed to atmospheric moisture which in turn reduces the strength, durability and stiffness of the structural member. So, as soon as spalling is spotted, it should be properly repaired otherwise it compromises with concrete surface integrity.

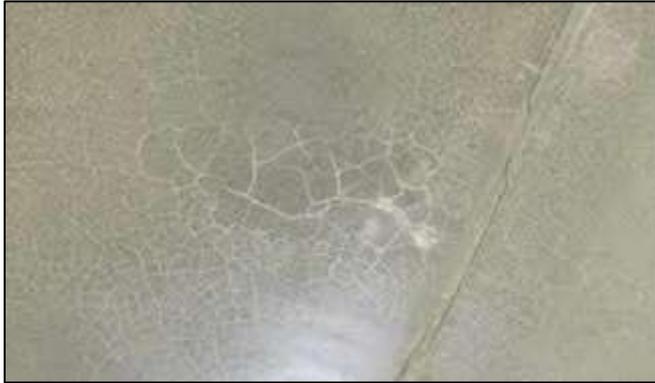
Fig. 1.5: Delamination of Concrete 1.5: Tests to be conducted on the RCC structure.

Delamination of concrete may be defined as the detachment of thin layers of concrete from the concrete member. It can be detected by tapping the concrete surface by light hammer. If dull sound is heard indicates the presence of delamination. In the spreadsheet, it is indicated by the surface area to be recorded.
