A Survey Paper on- Effect of High temperature in Reinforced Cement Concrete Structure

Abstract— This topic also gives a comprehensive knowledge on the overall strategy for the restoration of fire damaged buildings and also presents a critical appraisal of the assessment procedures by different nondestructive techniques, specifications and execution of repair techniques. The experimentation has been done to find out the impact of the fire on reinforcement steel bars by heating the bars to 100°,300°,600°,900° centigrade of 6 samples each. The heated samples are rapidly cooled by quenching in water and normally by air cooling. The change in the mechanical properties are studied using universal testing machine (UTM). The general conclusion is that majority of fire damaged RCC structures are repairable. But the impact of elevated temperature above 900°C on the reinforcement bars was observed that there is significant reduction in ductility when rapidly cooled by quenching. In the same case when cooled in normal atmospheric conditions the impact of temperature on ductility is not high. By heating the reinforcement bars, the mechanical properties can be changed without varying the chemic

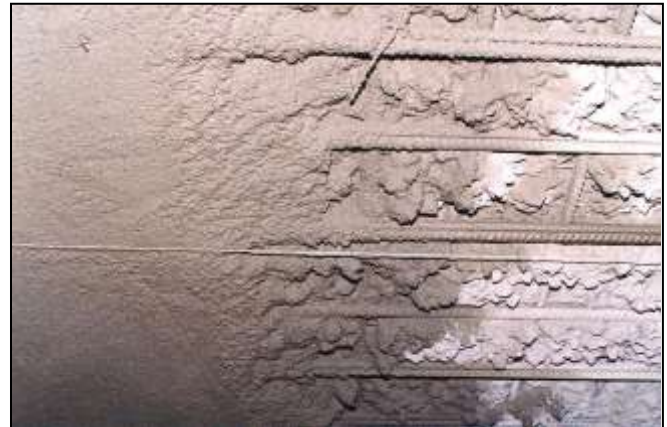
Fig. 1: concreting of fire damaged slab

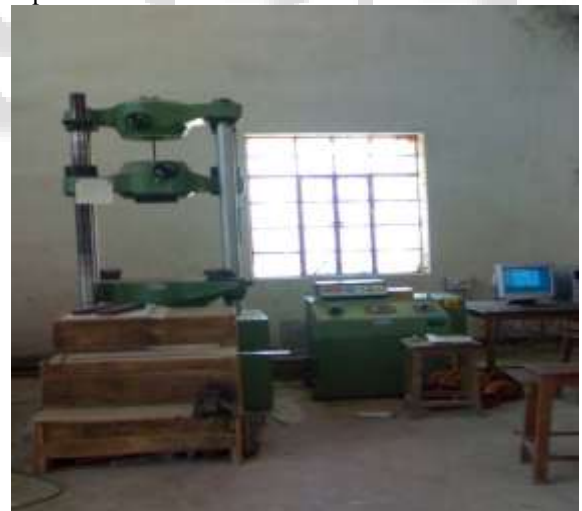
The 12mm steel bar is cut to a length of 40 cm and gave a gauge length of 60mm. The specimen is fixed on the machine and the required data on the computer is given. Test is conducted at a load rate of 300 kg/min for all the specimens. The data of the test is noted in computer during the test by default s it is setup. After the test all the other parameters like ultimate load, maximum extension in mm, area in mm², ultimate stress, elongation in percent, reduction in in area, young's modulus, yield stress, .1% and .2% stress and many other parameters can be observed.

Fig. 6: UTM testing setup
