Assessment of Waterlogged Areas in Kheda District, Gujarat, India using Remote Sensing

Dhvani M. Mistry¹ Mrugen B. Dholakia² Indra Prakash³
¹ME Student ²Professor ³Faculty BISAG and Ph.D. Supervisor
^{1,2}LDCE, Ahmedabad ³GTU, Gandhinagar

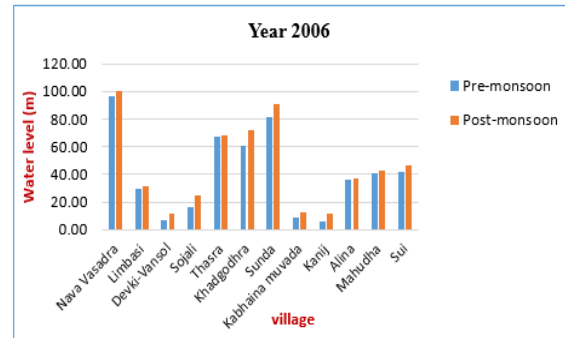
Fig. 4 : Ground Water Level In Year 2006

The following graphs show Ground water level of different villages of Balasinor, Matar, Mehmedabad, Thasra, Kapadvanj, Mahudha Talukas where waterlogging takes place due to rise in water level in post-monsoon compare to Pre-monsoon.

The above graph shows that the water level is highly rising in Sunda of Kapadvanj Taluka, Nava Vasadra of Balasinor Taluka, Khadgodhra of Thasra, and Thasra Taluka have threat to get waterlogged.

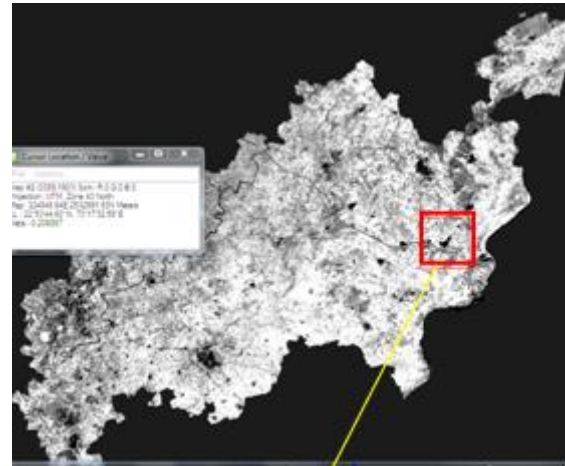
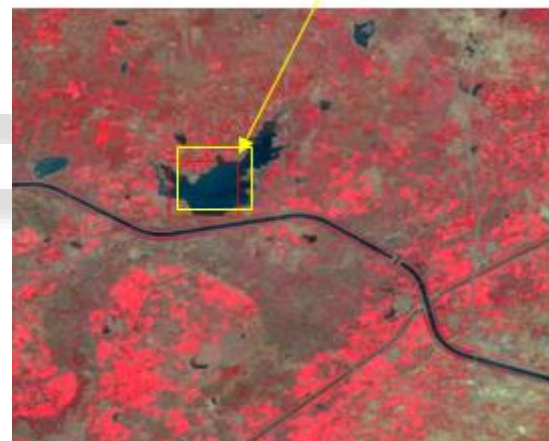
Fig. 8: Identifying waterlogged areas

False colour composite (FCC) constituted by three bands NIR, R and G bands are used for delineation of surface waterlogged areas.
