Comparative Study on Crack Pattern of RCC and Brick & RCC Composite Beams

Piyush Kumar¹ Mr. R.D. Patel²
¹P.G. Scholar ²Associate Professor
^{1,2}Department of Civil Engineering
^{1,2}M.M.M.U.T. Gorakhpur, India

Abstract— This paper presents a study carried out on Crack Pattern and Failure modes of RCC and Brick & RCC Composite Beams. The main objective of this thesis is to study replacement of concrete by bricks. The concrete of tension zone has been replaced by Brick in order to reduce weight and cost of the reinforced concrete beams. An experimental program is conducted on six simply supported concrete beams. All six beams cast in 2 different groups and every group having 3 beams. The first group of beams is of reinforced concrete beams and second group of beams are composite beams. The Crack Pattern of both groups of beam compare with each other. The comparative study result on Crack Pattern is taken with the help of load deflection reading by using dial gauge. The dial gauge are at position $L/6$, $L/3$, $L/2$, $2L/3$ and $5L/6$, where L is the length of beam.

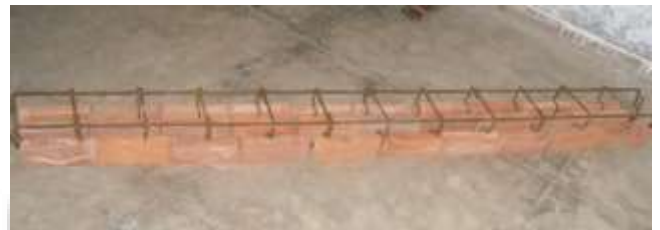
Fig. 2: Arrangement of Bricks with Reinforcement Cage

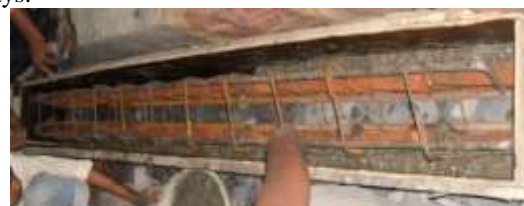
Fig. 4 Casting of Beam

For conducting experiment , six reinforced concrete beam specimen of sizes as shown in the figure effective length $l_{eff} = 2.4m$, breadth of beam $b = 0.23m$, depth of beam $d = 0.25m$. The mix proportion used is for water, cement, fine aggregate and coarse aggregate is taken. The mixing is done by hand mixing. The beam cured for 28 days. For each beam 2 cubes and 1 prism were casted to determine the compressive strength and flexural strength respectively for 28 days.

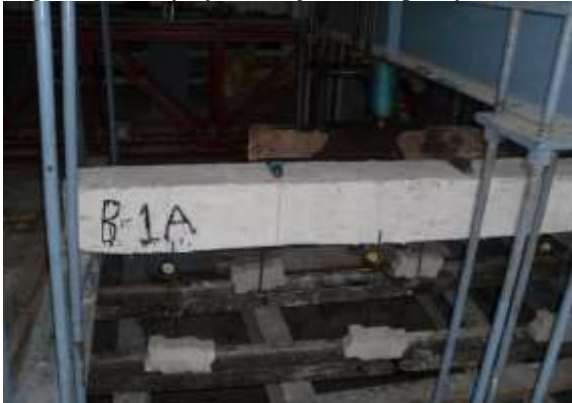
Fig. 5 1st group B-1A on Testing Frame..

The testing procedure for all the specimen is same. First the beams are cured for a period of 28 days then its surface is cleaned with the help of sand paper for cleared visibility of cracks. The two point loading arrangement was used for testing of beams. This has the advantage of substantial region of uniform bending, the two point loading system is provided is being showed in figure. The load is transfer through load cell on to the spreader I beam. The spreader I beam is installed on rollers seated on desired point of beam loading was done by hydraulic jack of capacity 100KN.

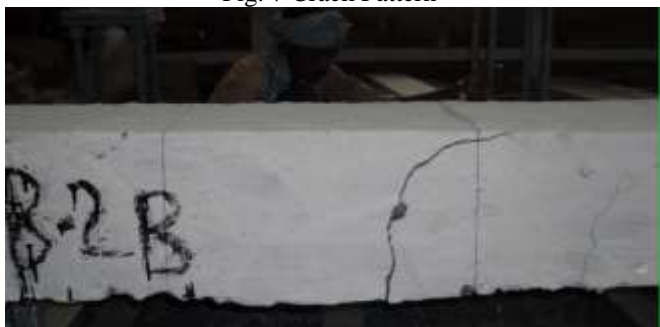
Fig. 8: Failure of 2nd group of beam at Ultimate Load

In group second B-2 as the load is being applied the first hair line crack is observed at 44kN. The most of the cracks are being seen between $L/6$ and $5L/6$. The cracks generate from bottom and then propagate towards the compression zone where point load is being applied. Small cracks appear near $L/6$ and $5L/6$ of beam. In case of beam B-2C cracks propagates in a zigzag manner and seen flexure area near $L/6$ and $5L/6$. The cracks are propagated from bottom and joined around compression region. At end of beams the cracks are being seen and are at 30° to 40° . A large crack appear where point load is being applied.

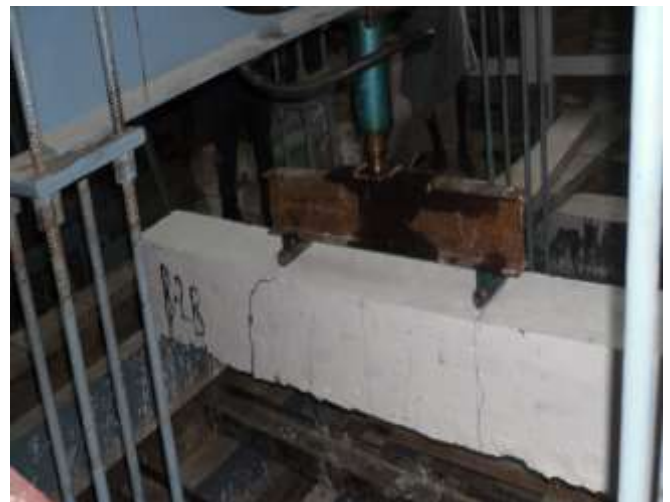
Fig. 9 Crack Pattern of 2nd group of beams

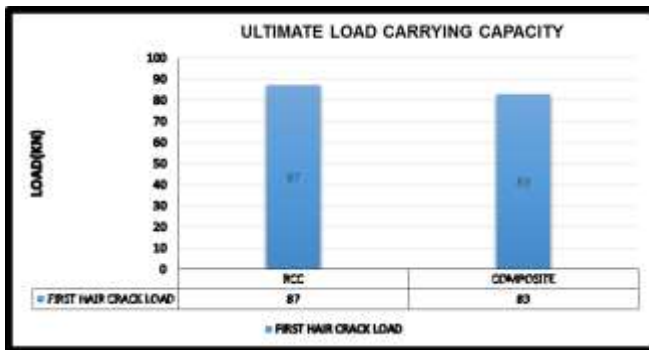
C. Ultimate Load Carrying Capacity

By this study it has been observed that RCC group beams B-1 has greater load carrying capacity as compared with composite group beams B-2.

Control beams shows a little bit more ultimate load as compare to composite beams. So group beam B-2 has desired strength as group B-1.

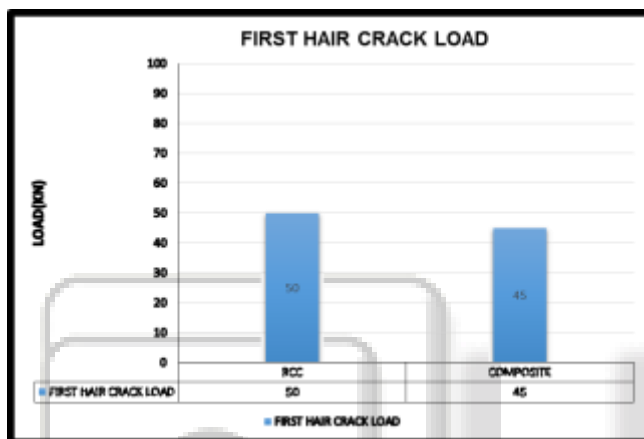
D. First Hair Crack Load

It has been observed that RCC group beams B-1 has more first hair crack strength as compared with composite group beams B-2.

It has been observed that RCC group beams B-1 has more first hair crack strength as compared with composite group beams B-2.
