Advancement in Through Hole Absence in Drilling Operation

Abstract— This paper presents a review of vendor facing problem of drill breakage while doing 2nd hole in component named as U.J. Cross. In this report firstly, we founded problem to drive absence of through hole missing of lubrication hole operation which cause high PPM of company supplier X. Our focus was on to Find and eliminate problem for drill break (through hole absent) during lubrication drilling operation in X cause 66% to total rejections contributor. We had checked the part visually and thought about it where and why the problem came. We converge on Scrap Characterization, Reintroduce not good Part to Process, Operation Search. After in this case study we had done a test, by adding a speed sensor to SPM drilling machine. Action implemented on one machine shows the visibly difference in rejection % in action implemented & other 3 machines. We understood Speed sensor reduces speed while chip is in between part & drill cause more energy to drill & results in drill breakage. The problem magnitude of chip direction cause drill breakage. Then we had applied Speed sensor installed to all SPM machines & solution Run Char

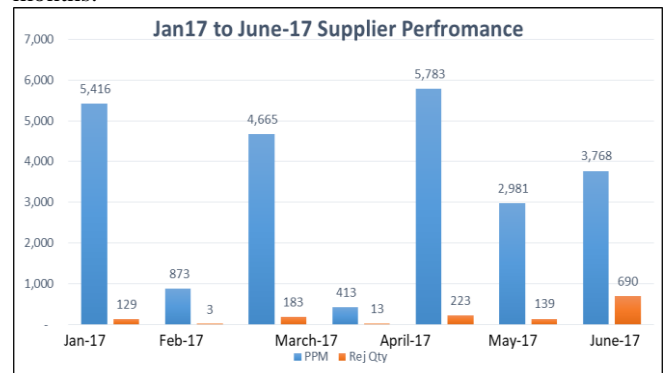
Graph 1: Jan – June supplier performance

Drill breakage issue were present in U.J Cross component, while drilling. At every second hole of U.J Cross the drill gets break. So, we have taken the details about problem background. Taken the data of PPM and rejections of last 5 months.

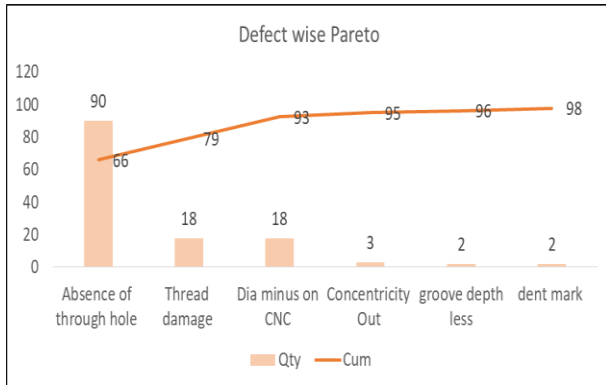
Graph2: Defect wise pareto

In the problem background we have also take the data of defect wise pareto for finding by which defect more rejections are found in U.J crosses. Defect wise pareto chart is a type of chart that contains both bars and a line graph, where individual values are represented in descending order by bars, and the cumulative total is represented by the line. The left vertical axis is the frequency of occurrence, but it can alternatively represent cost or another important unit of measure. The right vertical axis is the cumulative percentage of the total number of occurrences, total cost, or total of the unit of measure.

- In process machining defect is 90% & material handling defect like dent is 10 %
- Defect wise Pareto shows major defect generator on SPM drilling machine almost 66% out of all defect CNC operation defect 13%, SPM Tapping cause defect 13% & other defects 8%
- Through hole absence in cross defect cause 66 % rejection as per pareto.

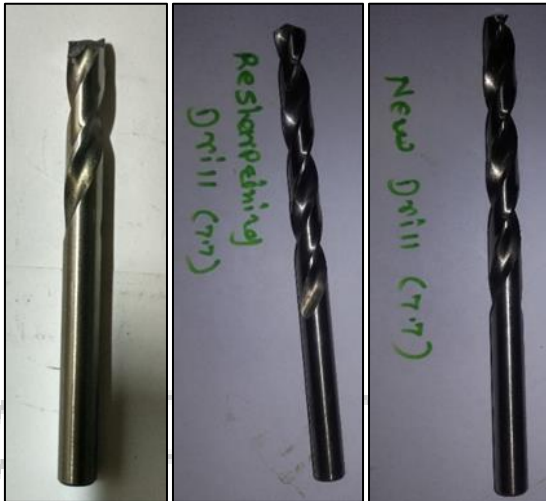
Fig.1: Fig1: Broken Drill. Fig. 2: Sharpened Drill
Fig 3: New Drill

Visited to the X supplier and seen visually the defect and click some pictures of broken drill & U J cross. There are four drills in U J cross after doing 1st drill while doing second drill, when the drill is at 90 degrees and it came to middle of the U J cross it gets break because the chips doesn't get space to come outward.

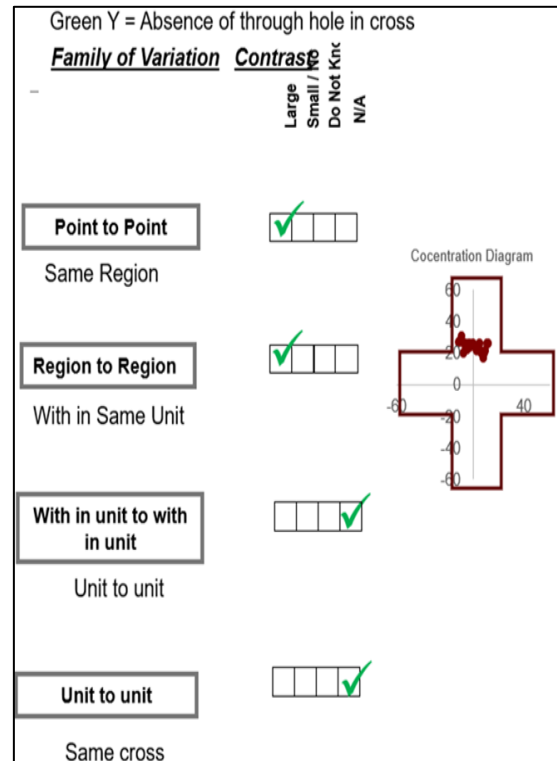
- Hole depth absence due to drill breakage inside. Depth reading shows variation of 10 to 15 mm shows that there is
- Point to point co-relation. Concentration diagram attached.
- Absence of through hole during stage second. Concentration diagram attached
- There is no specific trunnion as per forging. It is observed during concentration diagram data collection. It is depended on fixture & operation (Through hole first operation only)
- Data shows only 0.4 % rejection is not specific to parts, it is randomly.

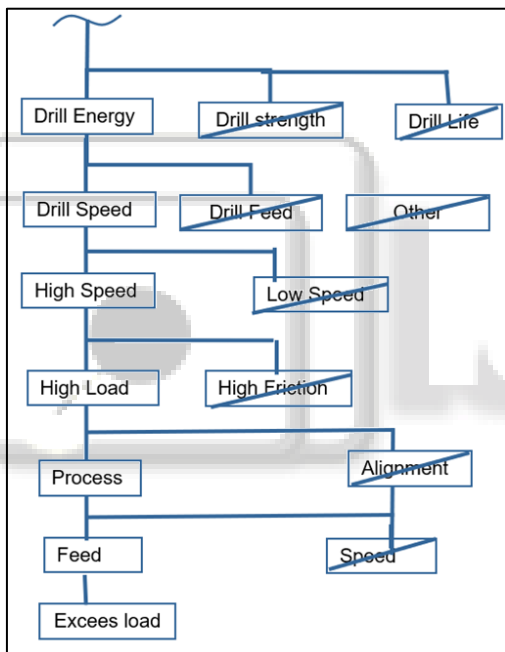
- Presence or absence of hole can easily be visually identified through examination of the part. so no Delta M & Isoplot.
- Concentration Diagram shows problem with first drilling & Through drilling
- Material Part material compared hardness & micro of BOB & WOW parts (BOB & WOW are of same heat code having same material property Drill material changed from HSS to carbide from in the month of Aug. No improvement in Rej.
- Drill life & changing frequency data collected on each machine in the month of June shows minimum drill broken at 10 & maximum 200 Nos. Drill life changed from 125 parts (500 holes) to 70 parts (280 Holes).
- Conduct trail for 20 Part with low speed feed & high-speed feed.

- Results are Low speed feed = 10 Nos OK High Speed feed = 08 Nos OK & 2 Nos Rej.
- Drill are with special blue coated to check the difference in consultant with drill manufacturing.
- Friction is going reduce drill life already validated above
- Alignment verified it is 0.02 micron & setup mandrel is available for to align SPM spindle & Fixture V.
- Compared BOB part drill & WOW part Broken drill under microscope with help of drill expert consultant given the direction of chipping as shown in next PPT Sketch.

- Table 2: Record of SPM after slowing speed of drill
- Problem = Chipping direction random due to high speed cause load on drill & drill break
 - Drill 10 sample each with special color applied on drill. For low speed & High Speed. Two parts are cause defect of absence of through drill.
 - Compared BOB & WOW broken drill under microscope shows pattern as per sketch in next PPT
 - Understand = Physics was in variation of chipping direction randomly
 - Corrective Action = As the Green Y is at the start of phase second entry point. We reduce speed at the time of entry & then it in going to be normal speed with the help of adding Super creep flow control switch & speed sensor. This work for both reduce entry speed as well as change speed when there is load on drill & prevent drill breakage.
