Evaluation and Management of Waterlogging Problems in the Command Area of Kadana Dam, Kheda District Using GIS

Abstract— Water logging problem occurring in the command area of Mahi Right Bank Canal (MRBC) of Kadana dam has been evaluated using remote sensing and Geographical Information Systems (GIS). Various thematic maps have been prepared such as topography, geohydrology, soil, land use, Digital Elevation Model (DEM) and synthesised with the ground water and surface water and collated with irrigation data in GIS environment. Major part of MRBC command area is occupied by Alluvium of Sabarmati and Mahi River and most part of the area is flat. Appreciable rise in the sub-soil water level has been observed since 1980 that is after starting irrigation through canal network of MRBC. Now major part of the Kheda district is either affected by water logging and salinization or presently under critical condition requiring immediate remedial measures and suitable management plan. Three talukas of Kheda district namely Matar, Mahudha and Kapadvanj are almost water logged and remaining under critical stage except part of Balasinor and Mehmedabad where water table is still in safe zone. Fla

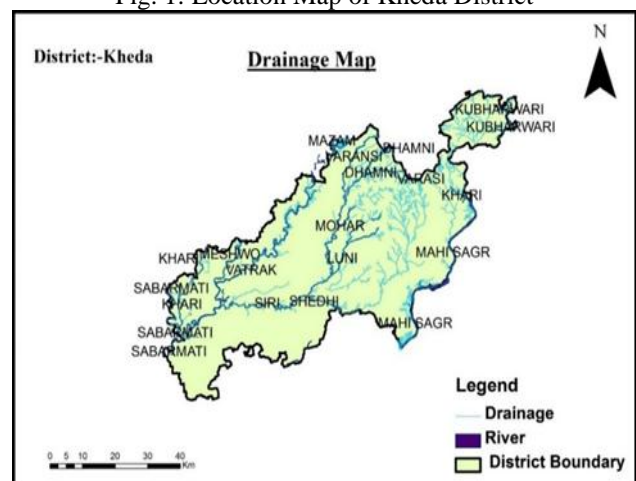
Fig. 2: Drainage Map of the Study Area

The MRBC area falls between latitude N 22°26'-N 22°55' and longitude E 72°19'-E 73°23'. The study has been done in the areas of seven talukas of Kheda district lying within command areas of MRBC (Fig. 1). Major part of the study area lies between Mahi and Sabarmati Rivers in alluvium (Fig. 2). Watrak and Shedhi rivers also flow across the area. The command area is irrigated by main canal and distributary canal system. Aggregate length of canal system network is 5600 km length. The cultural command area (CCA) is 212694 hectares. The climate is dry and semiarid except during the monsoon period.

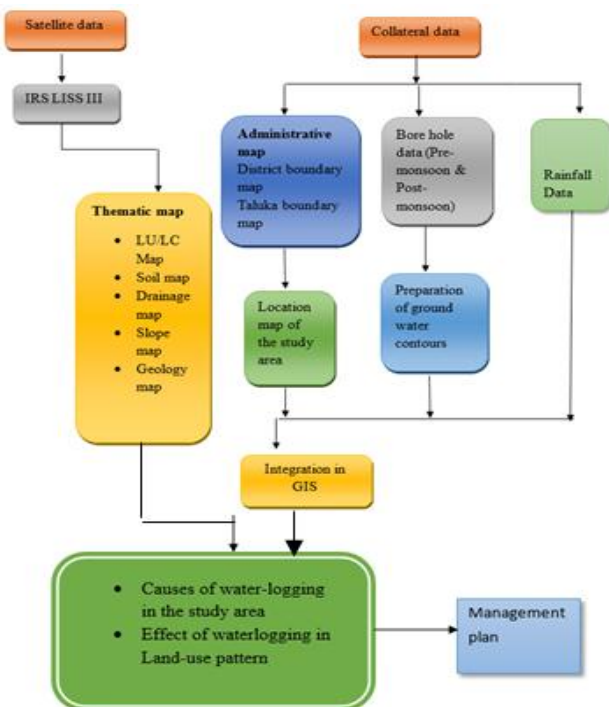
Fig. 4: Flowchart of methodology

The methodology adopted for the present study includes (Fig. 4):

- 1) Creation of thematic Maps (Land use, Contours, Slopes, geology, Soils, etc.) with the help of LISS-III images and Arc GIS software.
- 2) Collection and integration of collateral Data such as District Boundary, Taluka Boundary, Meteorological Data and Hydrological Data with the thematic layers.
- 3) Integration of various thematic layers and data using GIS to identify water-logged area. Analysis of thematic layers and data to develop suitable management plan.

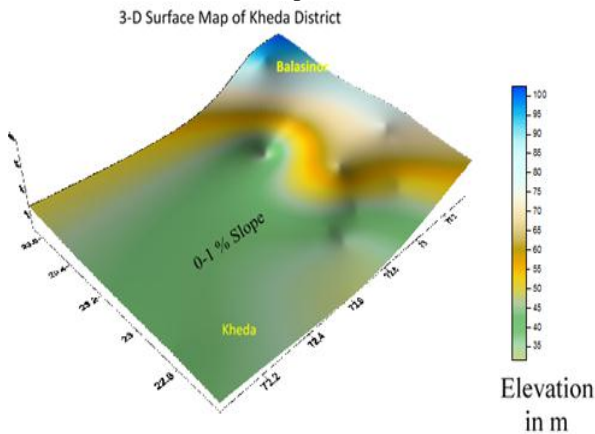
Fig. 8: 3-D Surface Map of Kheda District

Slope map was generated from Digital Elevation Model (DEM) of the area (Fig. 8 & 9). Major part of the command area is nearly flat (0-1%) creating ideal condition for low run off and thus high infiltration resulting in water logging problem in poorly drained area (Table 1).
