# Watershed Management in Sangave Village –A Case Study

**Abstract**— Watershed management plays a important role in minimizing soil erosion and water conservation. Some of districts in costal Maharashtra face the perennial problem of water shortage despite of getting heavy rainfall in monsoons insufficiency of water is particularly acute problem during the month after monsoon season. Ratnagiri is one such district, where a number of village and hamlets inhabited by adivasis or tribal’s face acute water shortage leads to many health and socio-economic problems. Also because of lack of knowledge of village level causes the water scarcity. This study aim to cater the water scarcity by implementing watershed management practices.

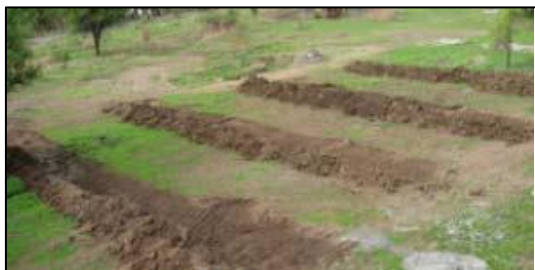
Fig. 2:

- 1) Treatment proposed on hilly area. On the hilly surface area treatment is proposed as soil erosion in large amount has taken place. Cautious contour trenches are providing on hilly surface. The aim of providing these trenches to reduce surface water flow velocity promotes infiltration and prevents pollution from drainage in to water bodies as shown in fig.
