Evaluation of Traffic Problems at Reliance Square (Kudasan, Gandhinagar)

Rohan V. Devdhar¹ Mr.Parth Patel²

¹Department of Civil Infrastructure Engineering ²Department of Transportation Engineering

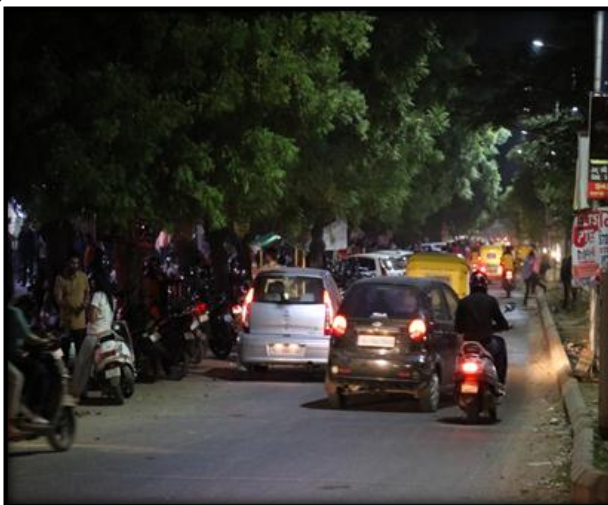
Fig. 1: traffic at study area
